MARINE GAS TURBINE HOT CORROSION
DEPENDENCE ON INGESTED SALT LEVELS

Report No. FR-11544

R.H. Barkalow and F.S. Pettit
United Technologies Corporation
Pratt & Whitney Aircraft Group
Government Products Division
West Palm Beach, FL 33402

16 April 1979

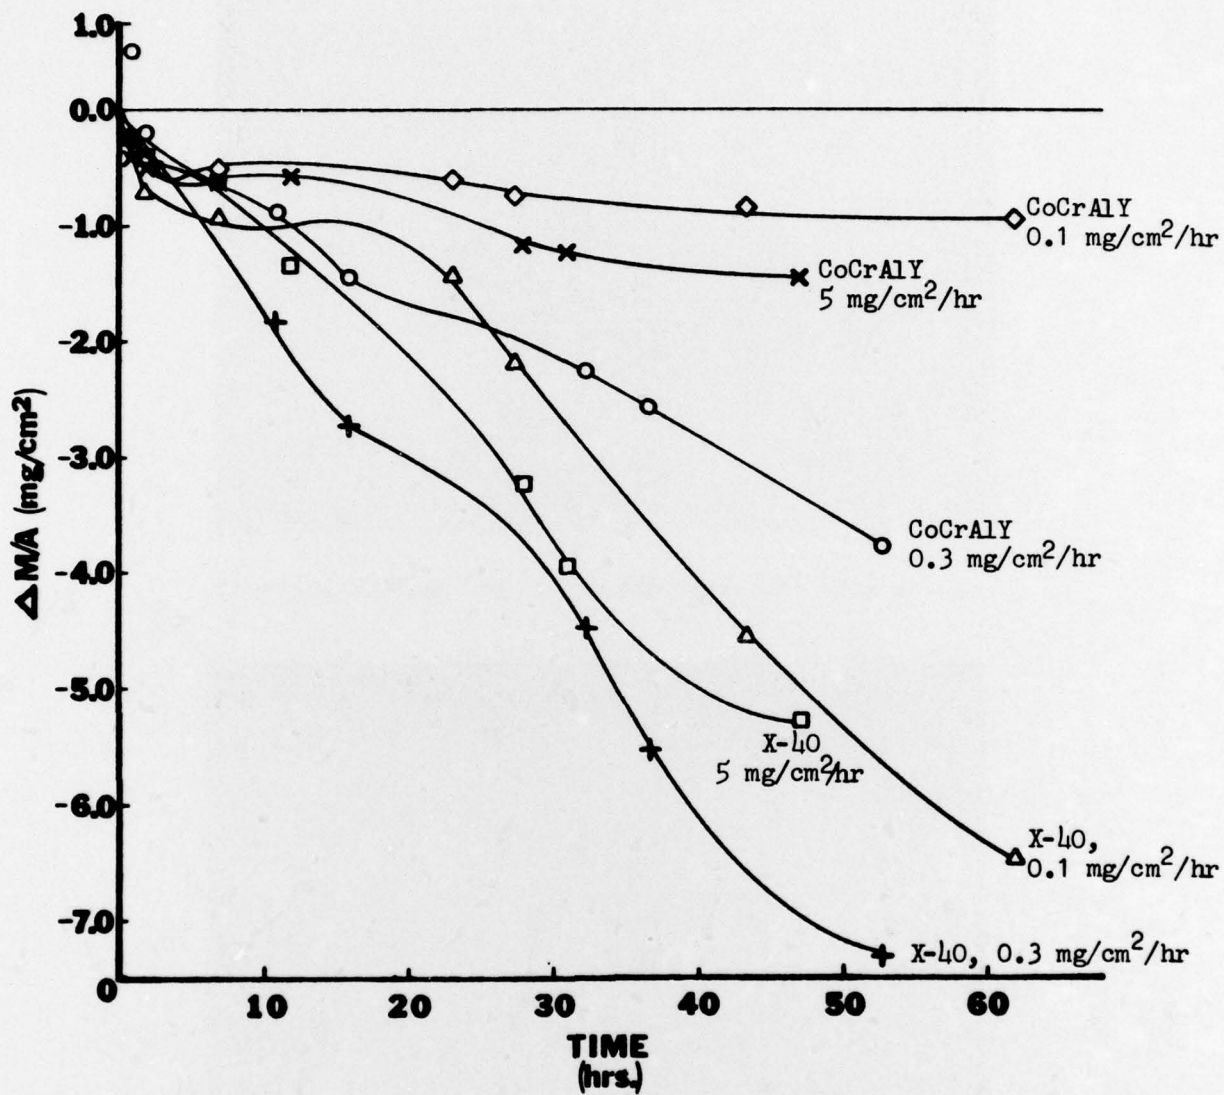
Figure 51. Weight change data showing effect of deposition rate on severity of attack of CoCrAlY coating and uncoated X-40 (concurrently exposed at each deposition rate) in 704C ducted burner rig hot corrosion test with ASTM sea salt and equilibrium SO_3 pressure of 5×10^{-5} atm.

Weight change data for the three tests in which $\Delta M/A$ was measurable are plotted on the same scale in Figure 51 to show parallel behavior of the CoCrAlY and X-40 which indicates that the data are internally consistent. Maximum attack was encountered at the intermediate deposition rate. At the lower rate, general surface degradation was much less extensive, but small pits were observable after the first hour of testing.

In the second test, at a higher deposition rate, the general surface degradation and localized pitting attack shown in Figure 53a were observed after 28 hours, and a deposit of the thickness shown in Figure 53b built up during the final overnight run prior to termination of the test. Detailed examination of the surface condition after 47 hours showed that many of the small pits observed at 28 hours apparently had not grown on further exposure; also the final weight loss was not as large as expected from the projection of the curve established by previous weighings. Such behavior - i.e. the failure to sustain a rate of hot corrosion propagation apparently established in previous exposure periods - is not uncommon in burner rig testing but is rarely observed under the more precisely controllable conditions of tube furnace experiments. An obvious possibility is a decrease in the severity of the reactive environment due to random fluctuations in burner rig operating conditions, with a ducted rig being perhaps especially susceptible to random variations in SO_3 pressures. Also, especially in the case of this test, the large ingestion rate may have built up a deposit of such thickness that the innermost salt/metal interface was protected from the effects of the reactive gaseous environment. Neither of these rationalizations, however, is supported by the large weight loss of the concurrently tested X-40 (see Figure 51).

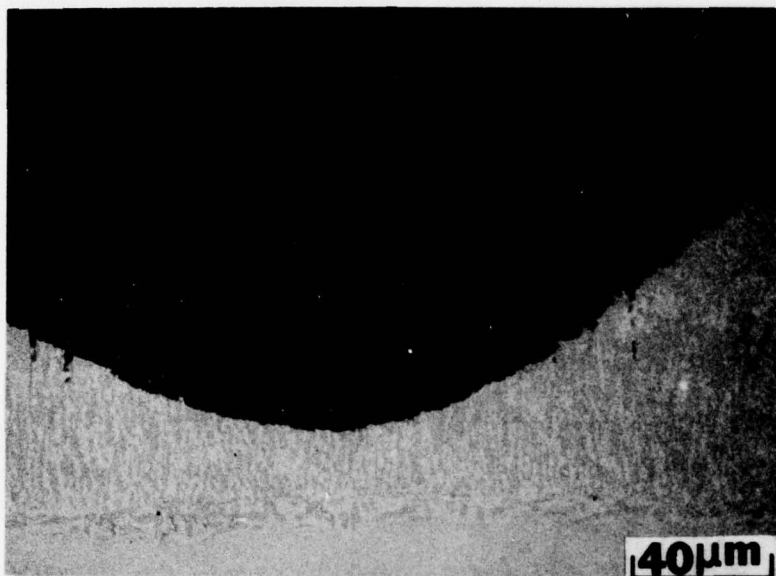
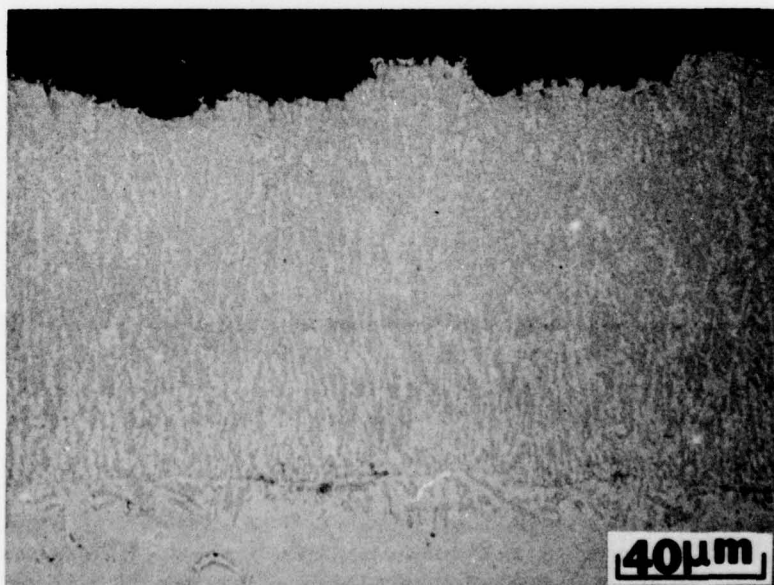
a. Maximum attack at about 70° gas/salt impingement

b. Typical structure at approximately 10° impingement

Figure 52. Depth and typical morphology of hot corrosion attack of CoCrAlY coating tested in ducted burner rig with ASTM sea salt and SO_2/SO_3 gas. Total exposure time = 52.7 hours at 704°C; calculated SO_3 pressure = 5×10^{-5} atm; measures salt deposition rate = $0.3 \text{ mg/cm}^2/\text{hr}$.

Photomicrographs showing the nature and severity of attack of the CoCrAlY specimen at the 0.3 mg/cm²/hr deposition rate are presented in Figure 52. As expected, the cross section through the cylinder showed a marked angular dependence of severity of attack, with the portions of the leading edge exposed to high angle impingement of the salt-containing gas stream being more deeply corroded than the sections which experienced low angle gas impingement. The trailing edge showed no discernable micro-

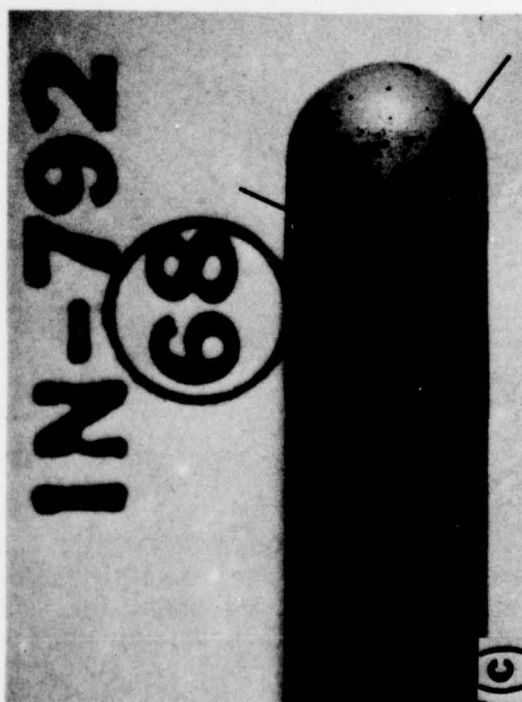
- (a) Surface condition after 28 hours. Arrows mark features visible in (c).
- (b) Salt deposit built up during 19-hour overnight run after taking photo (a).
- (c) Surface condition after 47 hours; i.e. after washing off the salt shown in (b). Arrows point to same features as in (a).

Figure 53. Surface condition of washed CoCrAlY specimen and salt deposit formed in 19-hour exposure at $5 \text{ mg/cm}^2/\text{hr}$ deposition rate.

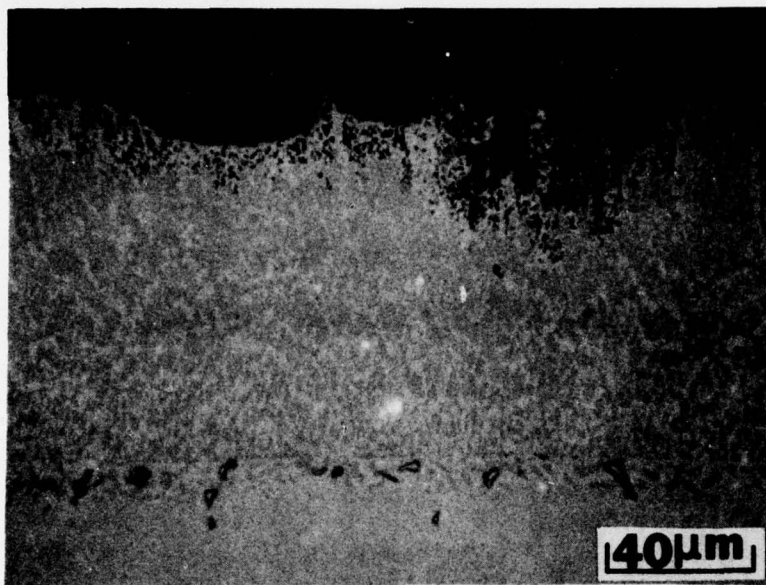
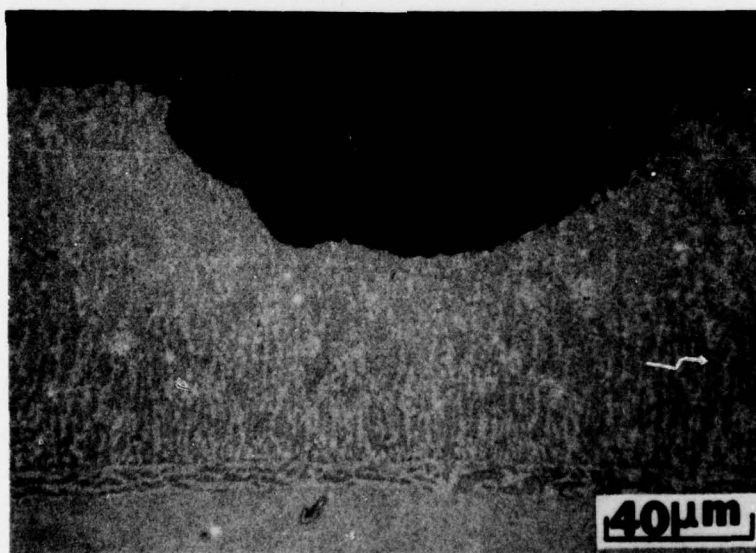
a. Chloride-type morphology near tip of specimen

b. Nodular attack near center of hot zone

Figure 54. Hot corrosion of CoCrAlY coating exposed 47.1 hours in ducted burner rig; environmental conditions were as described in Fig. 52 except for salt deposition rate of $5 \text{ mg/cm}^2/\text{hr}$. Extensive chloride-induced dealloying and internal oxidation as in top photo was not common; typical degradation microstructure was SO_3 -type nodular attack.

Post-test metallography on three sections through the CoCrAlY specimen showed maximum attack of about 50 μm and evidence of substantial chloride-induced dealloying in some areas (Figure 54). Of course it was initially suspected that the large amount of salt was not completely sulfated, but simple calculation showed that the moles of SO_2 added to the burner rig air supply was almost two orders of magnitude greater than the moles of chloride in the ingested sea salt and chemical analysis of the deposit washed from the sample indicated no detectable chloride.

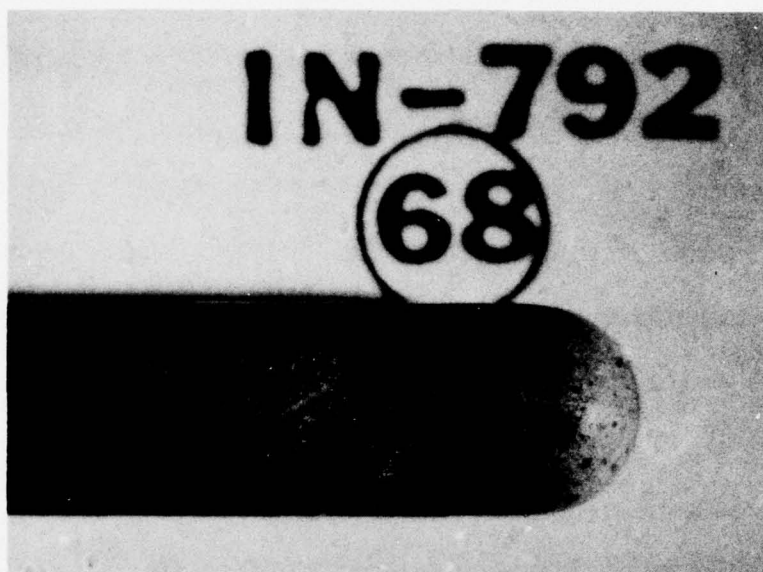
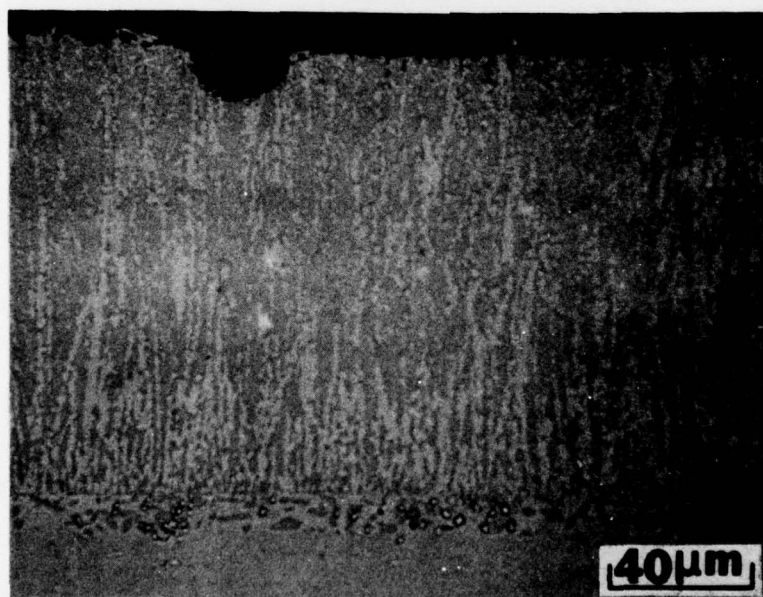
a. Surface condition

b. Depth of attack

Figure 55. Hot corrosion of CoCrAlY coating exposed 61.1 hours in ducted burner rig; environmental conditions were the same as for the specimens of Figs 52 - 54 except for salt deposition rate of less than $0.1 \text{ mg/cm}^2/\text{hour}$.

At the 0.168 g/hr ingestion rate, surface degradation of both CoCrAlY and X-40 were detectable after 1 hour of testing, and small but clearly measurable weight losses of the X-40 indicated continuing corrosion during a 61-hour exposure. Post-test metallography of the CoCrAlY showed less attack than anticipated from the surface condition; microstructural degradation in most areas was negligible and the deepest pit observed on several planes of polish was about 20 μm (Figure 55).

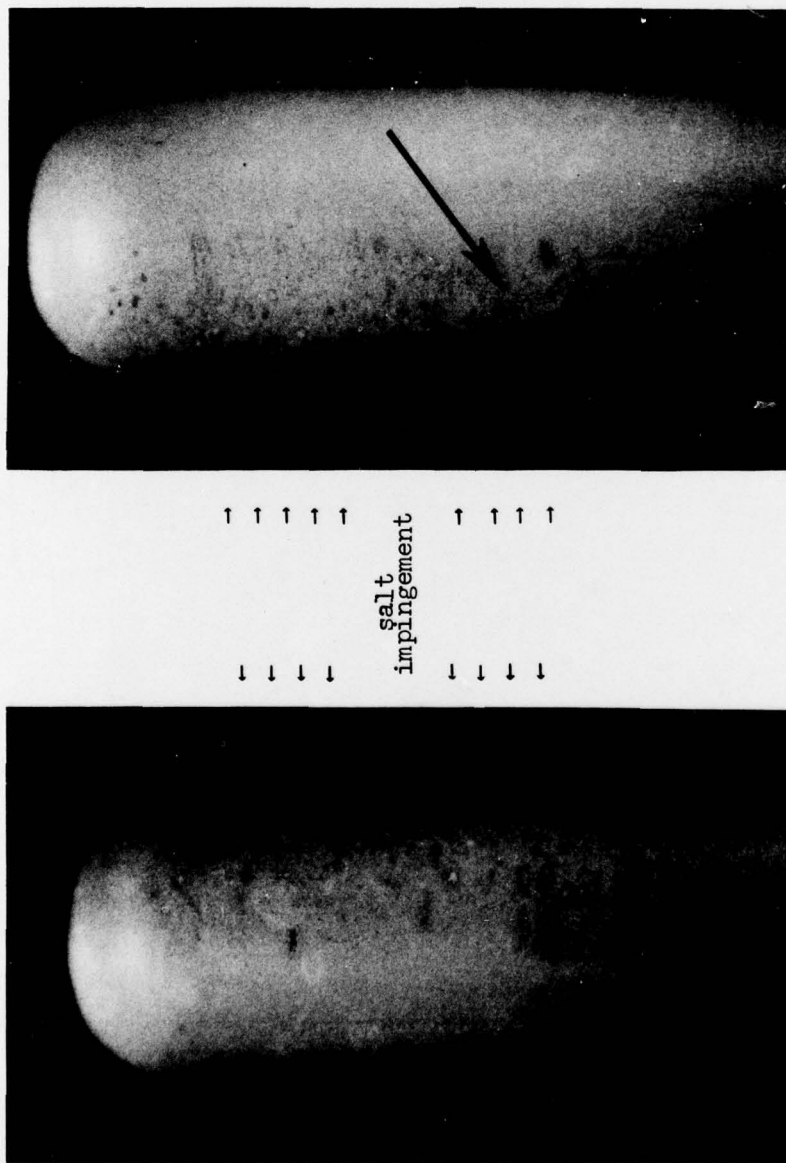
Figure 56. Surface condition of CoCrAlY-coated specimen exposed 6 hours to salt flux of $4 \text{ mg/cm}^2/\text{hour}$. Photos are opposite sides of same specimen, oriented to show difference between leading and trailing edges.

Visual observation of the CoCrAlY specimen after 2 hours of testing and careful water washing to remove rig spatter showed small green areas where the oxidation product was not the uniformly protective alumina characteristic of the trailing edge. Testing was continued, and the surface condition documented after a total exposure time of 6 hours (Figure 56). Continued exposure for a total of 21 hours resulted in slightly increased darkening of the leading edge surface, and careful examination with binocular and metallurgical microscope showed small pits of depth and frequency greater than attributable to oxidation in the absence of a condensed salt deposit.

No apparent differences in the general surface condition of the leading and trailing edges were evident on post-test scanning microscopy. Also the dull green areas observed on visual inspection were not discernable on the SEM, even though the transition between a greenish-colored area and the surrounding gray alumina had been marked with a microhardness indenter. However the line of fine dots marked in Figure 56 was found to be a series of small pits, typically of the size, depth, and morphology shown in Figure 57. Examination of randomly selected areas suggested that the entire leading edge was characterized by numerous pits of this type (of the order of 100 per cm^2), and no features of this nature were observed on the trailing edge.

The surface features in Figures 56 - 57 and the sulfur enrichment in the shallow pit of Figure 58 are considered unequivocal indication of hot corrosion attack induced by salt condensed from the burner rig flame. Such attack occurred even though the salt deposition rate was barely discernable by visual inspection. Moreover the fact that degradation of this extent was observable after a relatively short testing time is believed to represent an unacceptable rate of hot corrosion.

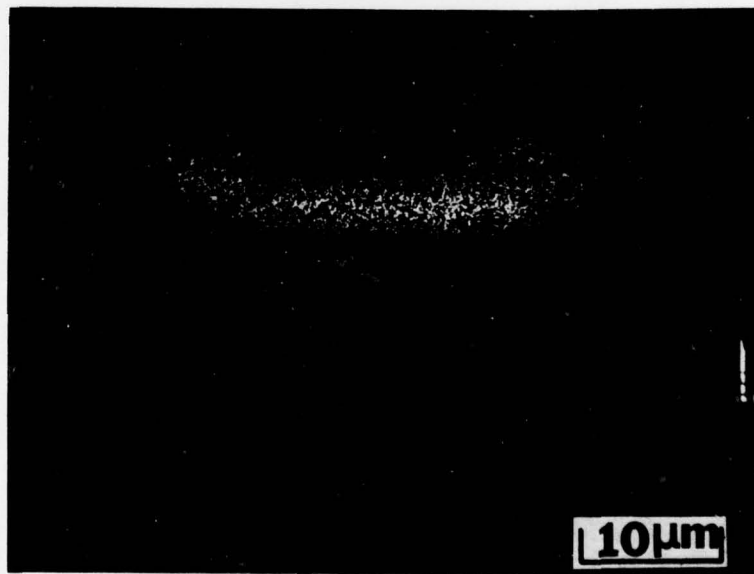
a. Back scattered electron image

Figure 58. Metallographic cross section presumably through a small pit of the type shown in Fig. 57.

The specimen was cut for metallography approximately in the center of the test zone. Metal consumption up to 5 μm was observed in several areas (e.g. Figure 58a), and the corrosion products were rich in sulfur (Figure 58b).

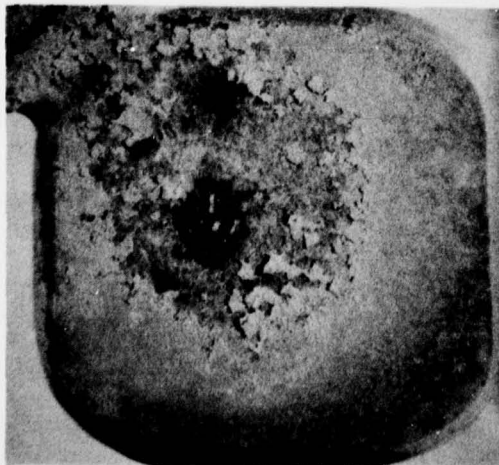
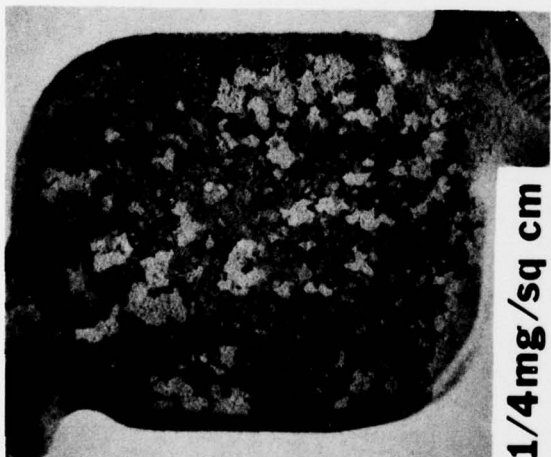
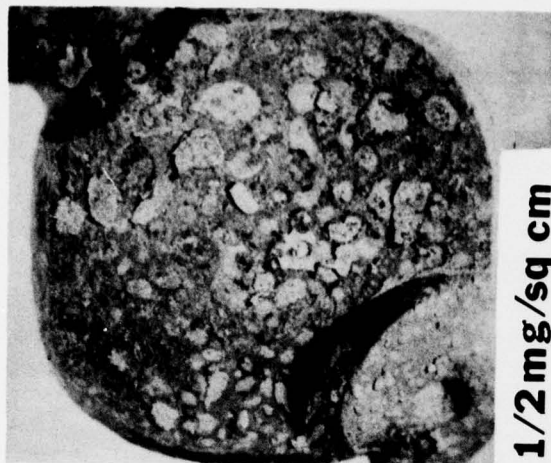
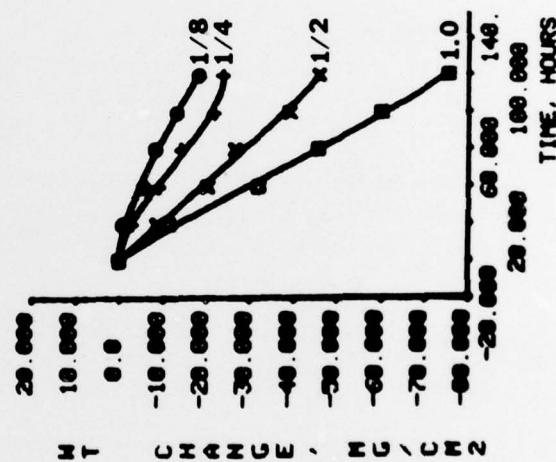
1/8mg/sq cm

1/4mg/sq cm

1/2mg/sq cm

1.0mg/sq cm

Figure 59. Surface photographs of CoCrAlY-coated coupons with various deposit thicknesses after 20 hours exposure in tube furnace at 704C and $\text{P}_{\text{SO}_3} = 0.0007$ atm; weight change data versus deposit thickness for 100-hour cyclic test.

Visual inspection after 20 hours showed an obvious dependence of severity of attack on amounts of applied salt (Figure 59). The difference in surface condition became less apparent as all of the specimens continued to degrade on further exposure, although weight change data remained remarkably consistent up to 100 hours (Figure 59). Post-test metallography showed that even the specimen with the thinnest deposit had suffered consumption of up to half of the coating thickness.
